Saving Atlanta's Centennial Olympic Park from Concert Damage

Sand capping with an inorganic soil amendment protects grass from hordes of music fans

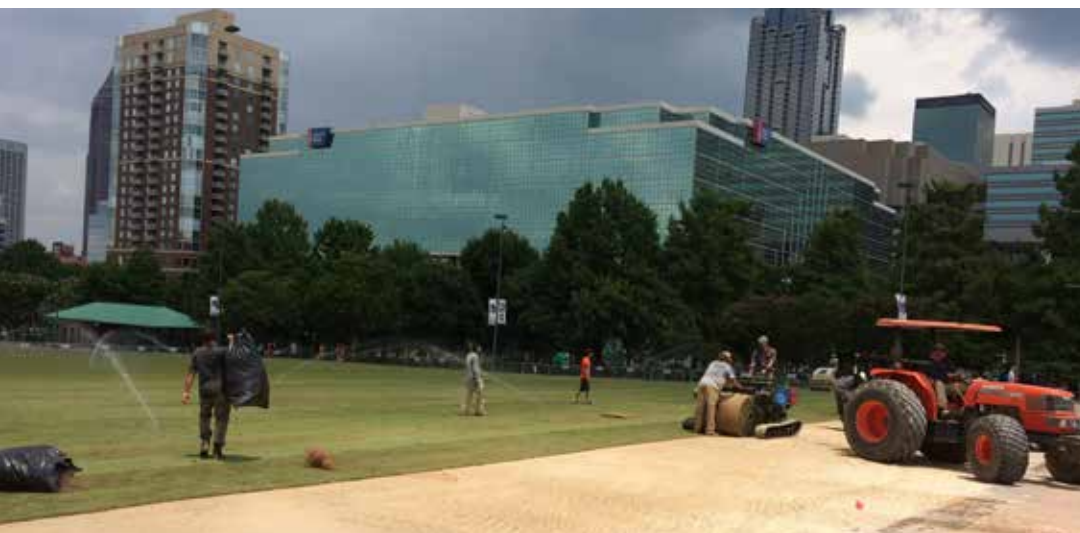
Crews install new sod on the surface of Centennial Park after completing work on an innovative sand-capped root zone to promote better drainage and minimize grass damage during rain events.

Most of the rain-ravaged section was simply aerated, fertilized and irrigated, but, on the advice of a local turfgrass specialist, park officials decided to create a 10,000-square-foot demo area using a sand cap-based drainage system similar to those used on golf courses. The system included a new subgrade topped by drainage tiles, a 4-inch layer of grav-

el, and a 6-inch layer of sand mixed with 15 percent Profile Porous Ceramic (PPC) Greens Grade — an inorganic soil amendment that holds moisture nutrients and improves firmness and drainage in sand-based root zones. The goal was to compare mud and damage resistance between the areas with and without a sand cap when rain struck.

Waltz recommended the sand-capping technique to create a subsurface drainage system that would flush excess water through the sand and gravel layers and into the drainage pipes. Based on his Ph.D. work, he also advised Centennial Olympic Park to mix an inorganic soil amendment into the sand layer at a 15-percent rate to produce a firmer surface and better drainage than the sand/peat mix that is frequently used for sand-cap projects.

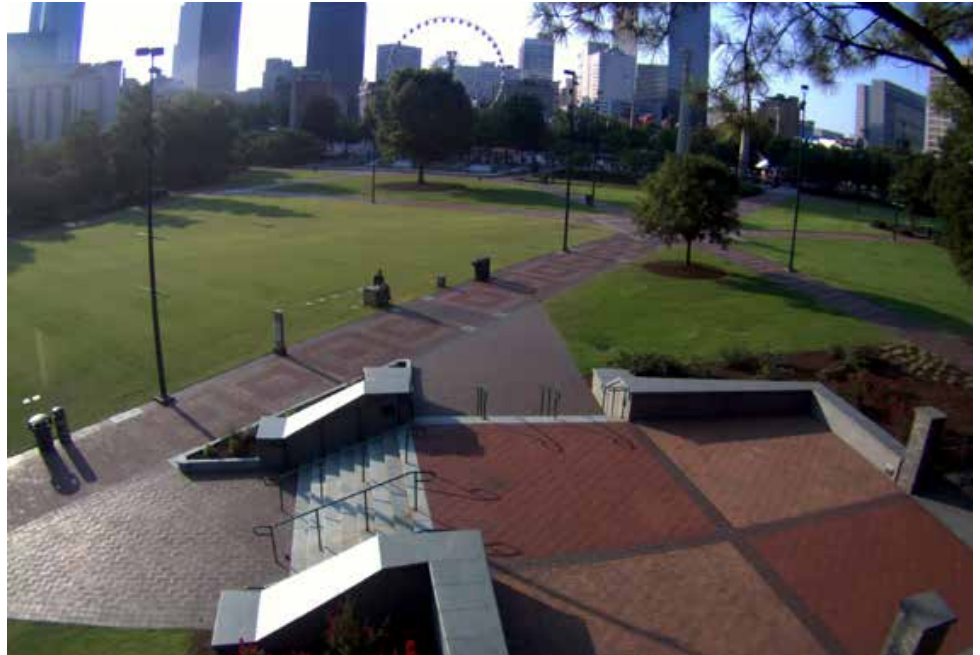
Once installed, the sand-capped section of the lawn looks identical to the rest of the park's grass-covered areas. The system of drainage tiles, gravel and sand mixed with an inorganic soil amendment is hidden beneath the sod.
