Atlanta's Centennial Olympic Park

PROJECT PROFILE

ATLANTA, GEORGIA

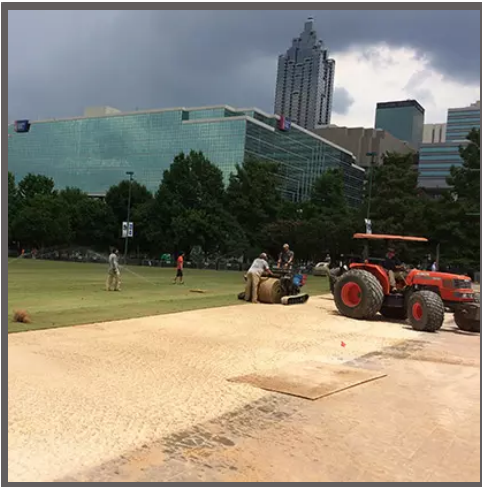
Park reconstruction underway

- Create a 10,000 square foot demo area to evaluate sand/PPC cap solution
- Install a new subgrade topped by drainage tiles, a 4-inch layer of gravel, and a 6-inch layer of sand mixed with 15 percent Profile® Porous Ceramic (PPC) Greens Grade™
- Compare post-rain turf conditions in areas with and without a sand cap

The sand cap demo area with Profile® Porous Ceramic (PPC) Greens Grade™ outperformed the untreated native soil, delivering a percolation rate of 13 inches per hour by flushing excess water through the sand and gravel layers and into the drainage pipes. The first big test came in October 2015 at a sold-out Foo Fighters concert attended by 20,000 fans. Despite near-daily rain from the previous week and a steady drizzle during the event, the grass in the sand-capped section survived with little damage.
